In-flight break-up involving Robinson R44, VH-ZNZ

41 km NW Mossman, Queensland | 18 November 2016

ATSB Transport Safety Report
Aviation Occurrence Investigation
AO-2016-156
Final – 5 March 2019

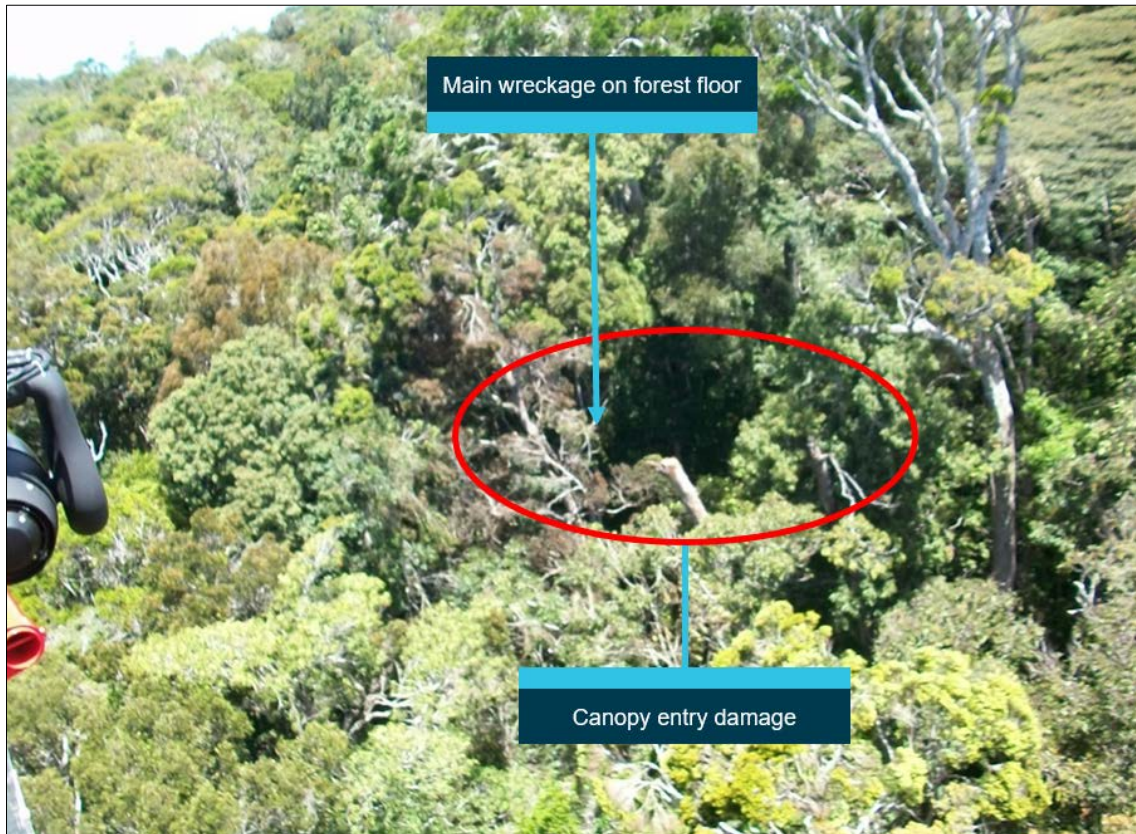
Figure 5: Approach to canopy entry directly above wreckage site

The helicopter was found to have broken into multiple fragments separated over an area of about 40 m x 50 m (refer to Appendix B). A separated section of tailcone, the empennage, tail rotor driveshaft sections and tail rotor blade debris were distributed to the west and south of the main wreckage. A post-impact fire had consumed the main body of the helicopter, but the fragments separated from the main body were undamaged by fire. There were several tall trees surrounding the main wreckage, which had evidence of fire damage, but little impact damage. The damage to the forest canopy was concentrated directly above the main body of the helicopter, which indicated a near vertical final descent with little main rotor rotational energy (Figure 5).

Rescue helicopter view of the damaged canopy. Main body of the helicopter is located on the forest floor, about 100 ft directly below the canopy damage.

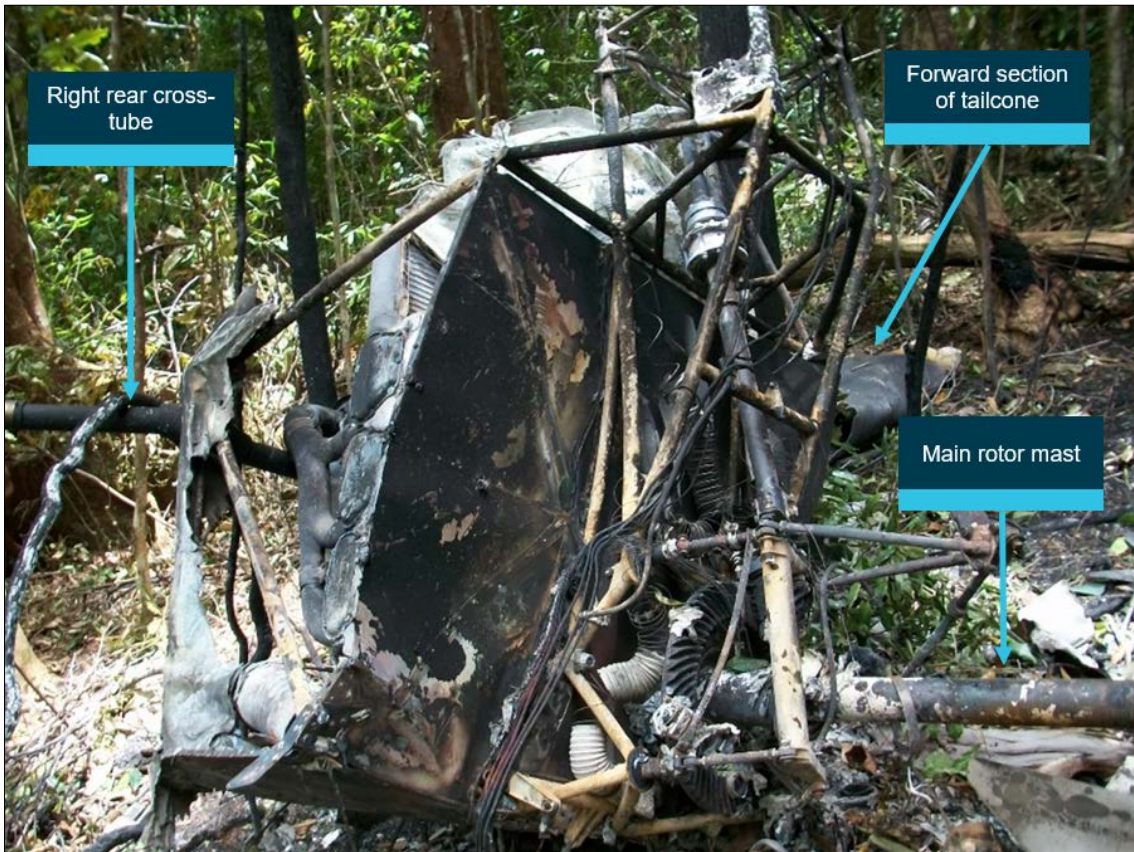
Figure 6: Main wreckage

The main wreckage included the helicopter frame assembly, engine, main rotor drive train and the main rotor. The helicopter frame was oriented left nose down in a south-west direction with high ground on the port (left) side. It showed evidence of significant burning as a result of a post-impact fuel-fed fire (Figure 6). Immediately beyond the main wreckage site, helicopter debris and flora were unburnt. The fire destroyed the main body and forward section of the tailcone. The aluminium and bladder fuel tanks had perished in the fire. The left landing gear skid tube extender was located in a position consistent with a left nose down impact.

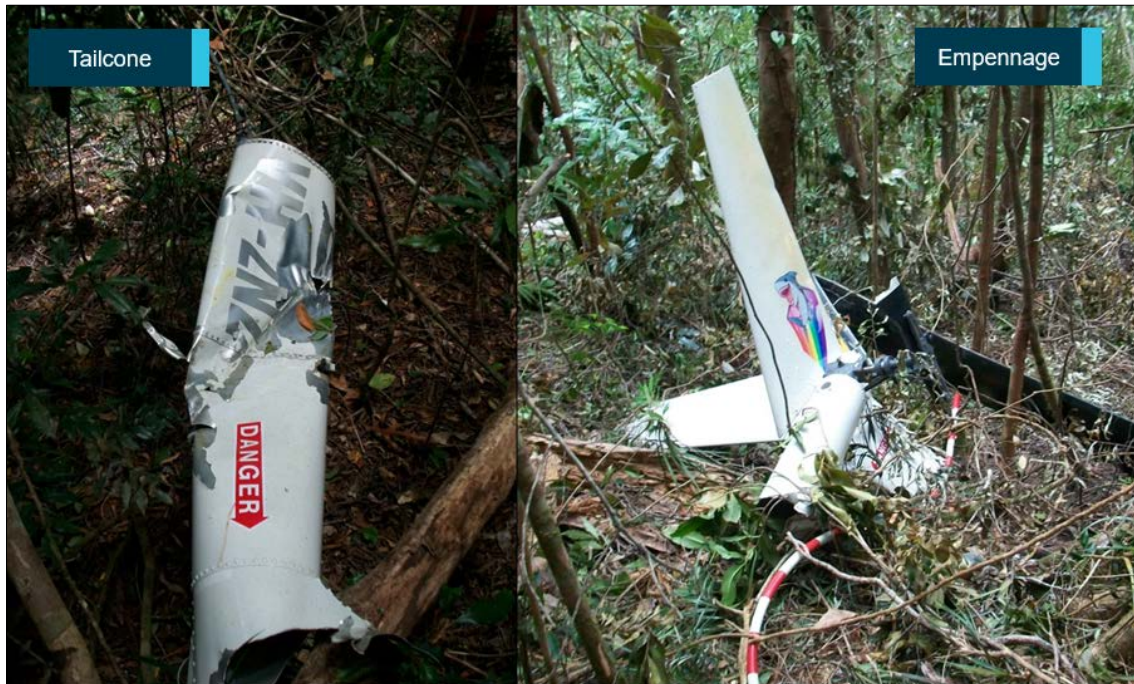
Figure 7: Separated tailcone (left) and empennage (right)

The rear half of the tailcone was found about 25 m south of the main wreckage with evidence of a main rotor blade strike mark and yellow paint transfer from the rotor (Figure 7). The forward separation point of the tailcone had a tension failure (pulled apart at the rivet joint). RHC reported that in power-on situations, the main rotor blades will cut through the tailcone and driveshaft. In power-off situations, and/or rotor speed reduced, it will ‘smash’ the tailcone, pulling the driveshaft out, which was consistent with the wreckage.

Left: the rear tailcone assembly with strike mark and yellow paint transfer in and around the strike was found to the south of the main wreckage. Right: the empennage was found adjacent to the main wreckage but outside the fire zone with both tail rotor blades separated.
 Source: Queensland Police Service, annotated by ATSB

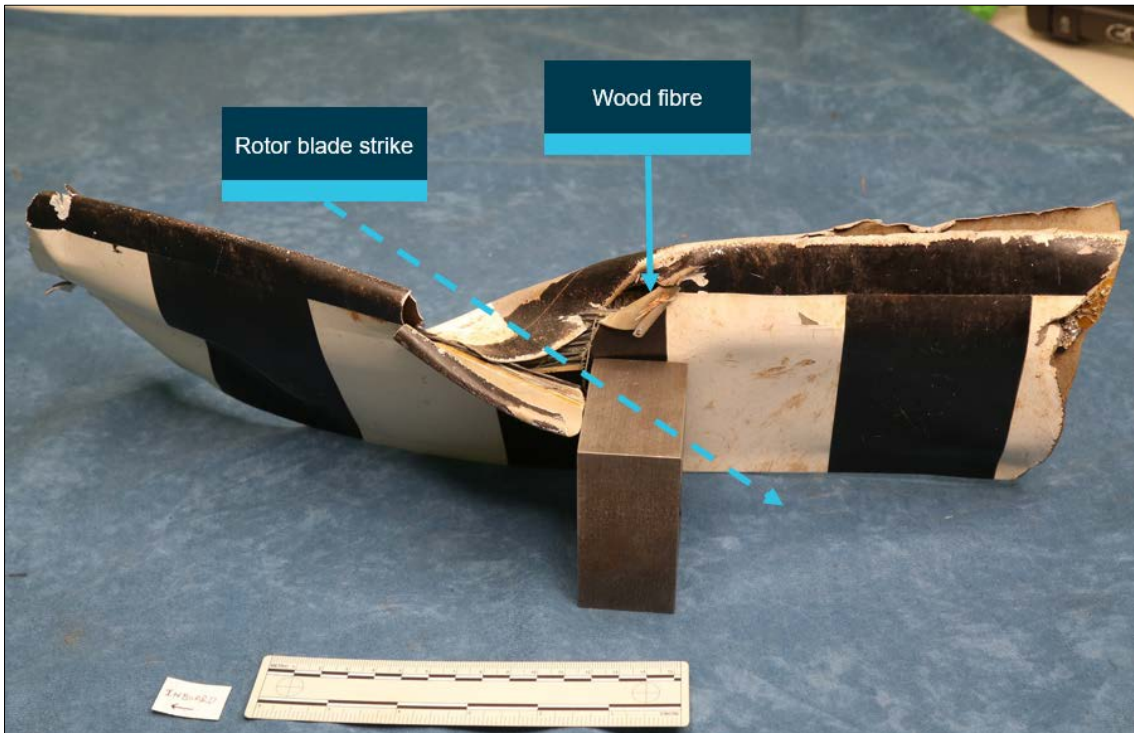
Figure 8: Tail rotor blade impact damage

¹⁷ RHC reported that the damage to the tail rotor blade in Figure 8 is more consistent with the tail rotor blade striking a tree than a main rotor blade striking the tail rotor blade. However, their response did not account for the tip bending and paint transfer evident in Figure 9, and the ATSB noted a scratch in the yellow paint of a main rotor blade, near the main rotor blade tip, consistent with contact with a tail rotor blade. Footnote 18 refers to an unsuccessful attempt to verify if the tail rotor blades did strike the same tree.

Tail rotor blade 1 with strike damage consistent with the leading edge of a main rotor blade.
Source: ATSB

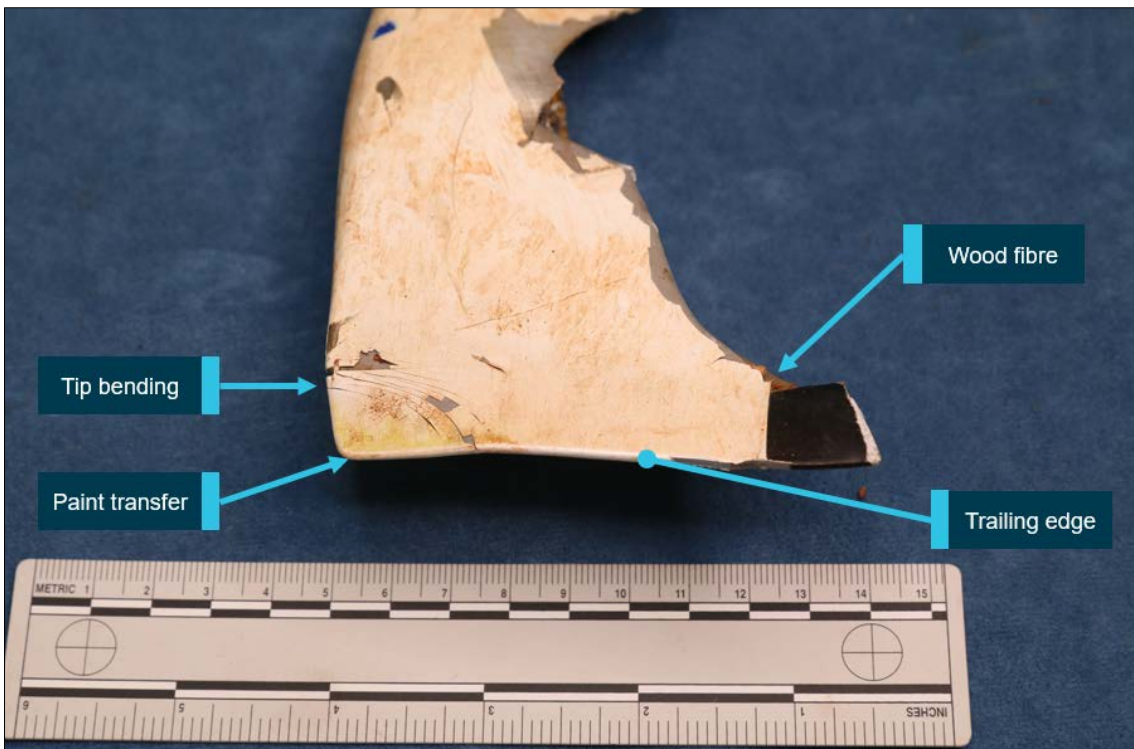
Figure 9: Tail rotor blade tip

Tail rotor blade 2 tip cap with yellow paint transfer from the main rotor and bending deformation.
Source: ATSB

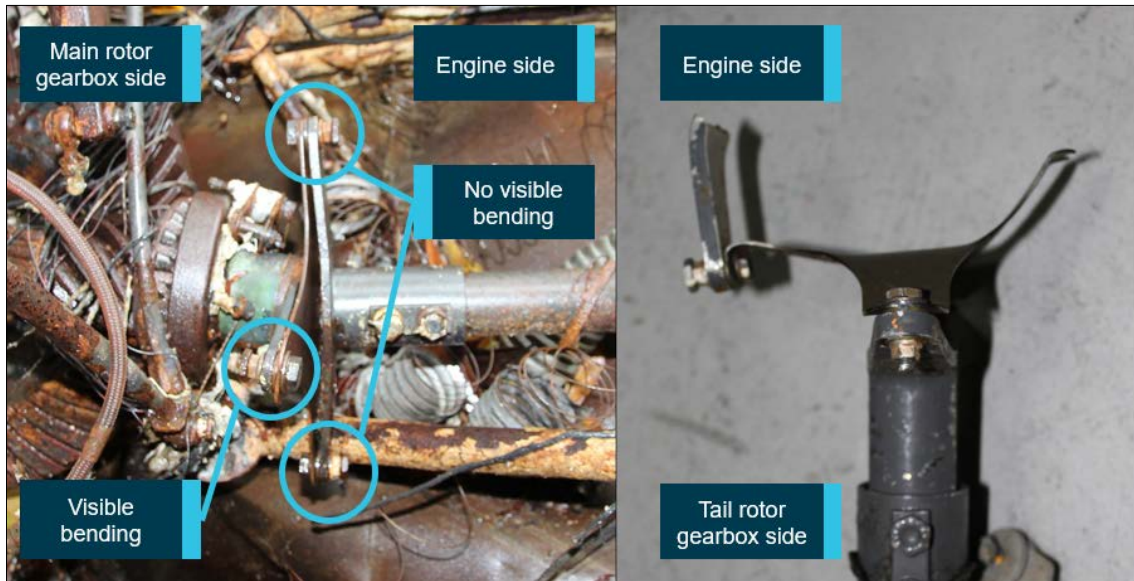
Figure 10: Forward flex plate (left) and intermediate flex plate (right)

spiral-bevel gear and mast roller bearings were visible and did not indicate any evidence of a catastrophic failure. The forward flex plate bolts exhibited minor bending on the main gearbox side, but not on the engine side (Figure 10). RHC reported that the deformation of the forward flex plate is consistent with damage from extreme angles between the yokes while being pulled apart. As the main rotor blades contact solid objects the mast will move fore, aft, left and right, which changes the angle of the input yoke of the gearbox. The entire airframe will flex, resulting in the yokes at all three flex couplings moving apart. They noted that in this case the forward flex plate bending was relatively minor.

Left: forward flex plate with visible bending of bolts on the main gearbox side, but not on the engine side. Right: intermediate flex plate exhibited tension failure, but no significant torsion. The V-belt drive from the engine was located between the two flex plates.

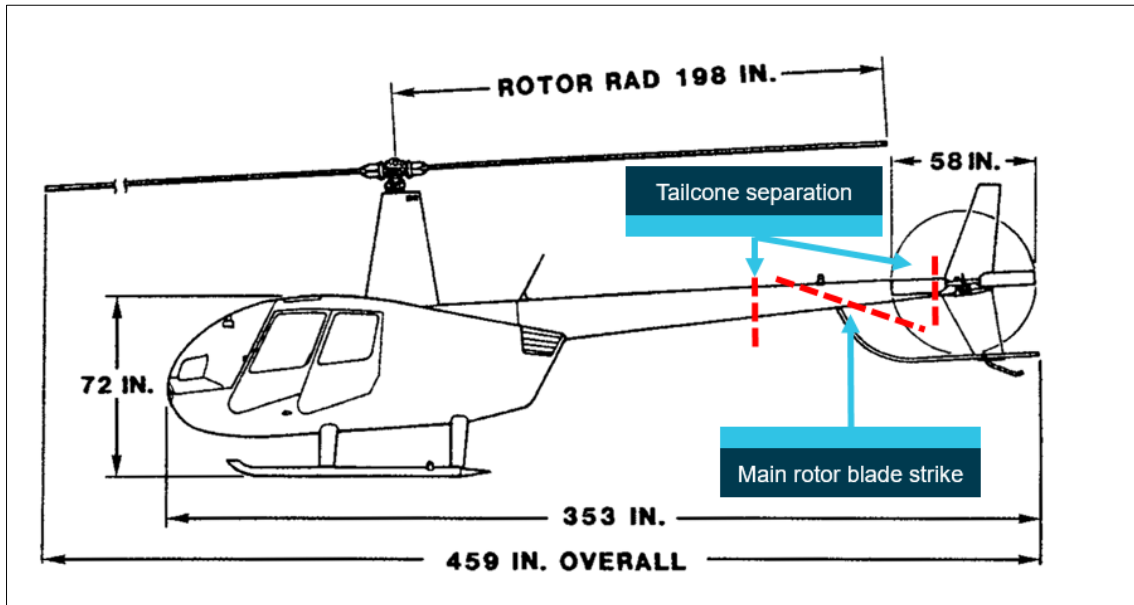
Figure 11: Approximate positions of tailcone separation

Figure 11 depicts the approximate position of the separation points. Of note, the main rotor cyclic rigging setting is 13.5–14.25°. The blade strike mark was at an angle of about 17–18°.

Main rotor blade strike and associated tailcone separation points.
 Source: Robinson Helicopter Company, annotated by ATSB

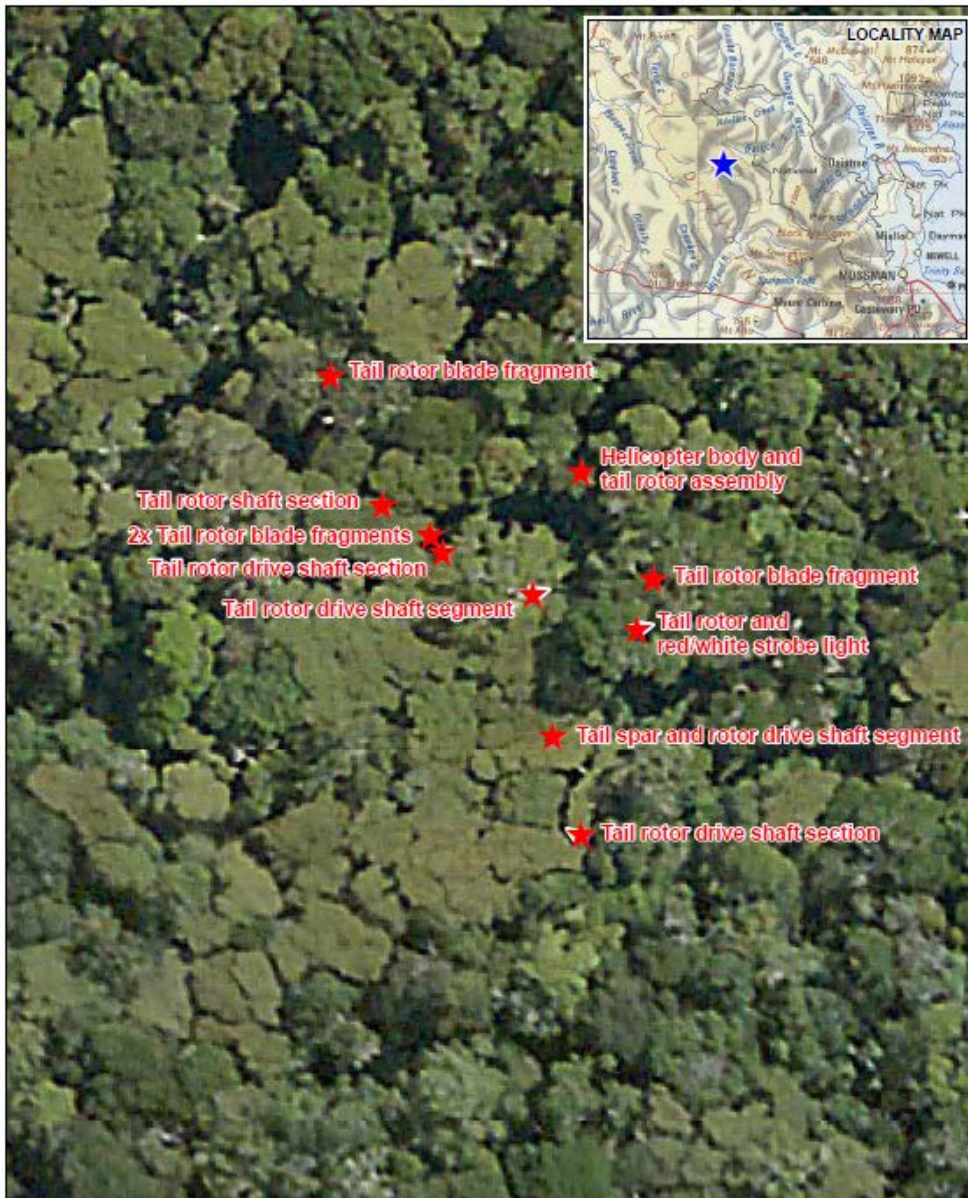
Appendix B - Distribution of the helicopter wreckage (North-Up)

The distribution of the wreckage, as mapped by Queensland Police Service. The item marked 'Tail spar and rotor drive shaft segment' refers to the tailcone with the seized section of tail rotor driveshaft inside.
