In-flight break-up involving Robinson R44, VH-ZNZ

41 km NW Mossman, Queensland | 18 November 2016

ATSB Transport Safety Report
Aviation Occurrence Investigation
AO-2016-156
Final – 5 March 2019

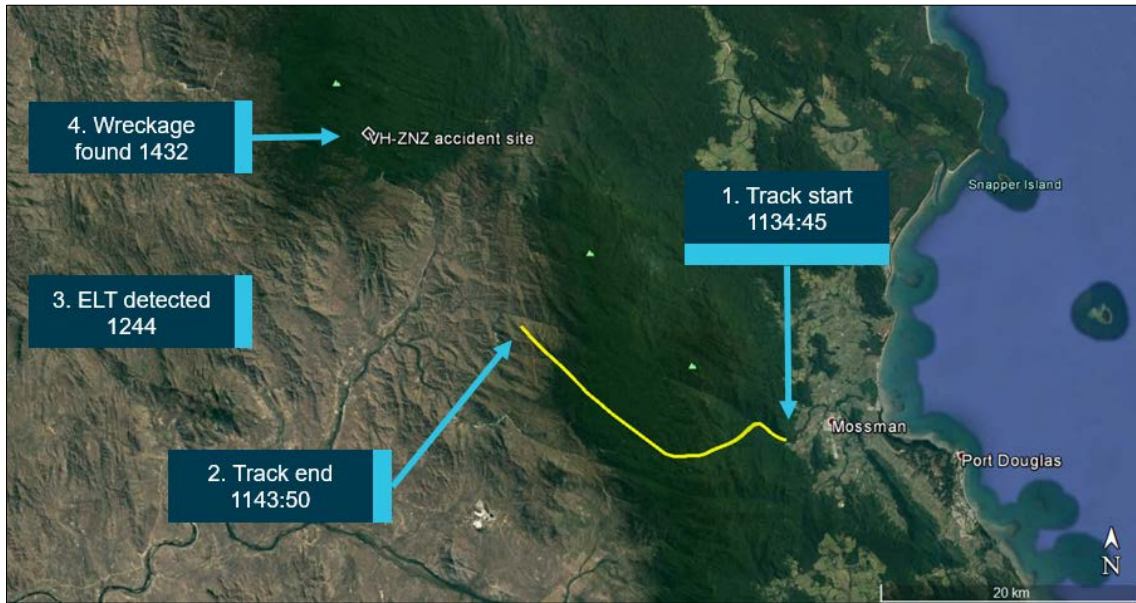
Figure 1: VH-ZNZ track and accident site

Figure 1 depicts the known flight path from recorded track data and the location of the accident site with key event timings. The end of the recorded track is consistent with an expected loss of coverage in that area at low level.⁴

Recorded track data for the flight from Mossman to the Mount Windsor National Park, which is the forested area surrounding the accident site. The start of the track is in the vicinity of the Mossman QPWS office.
Source: Google earth and OzRunways, annotated by ATSB

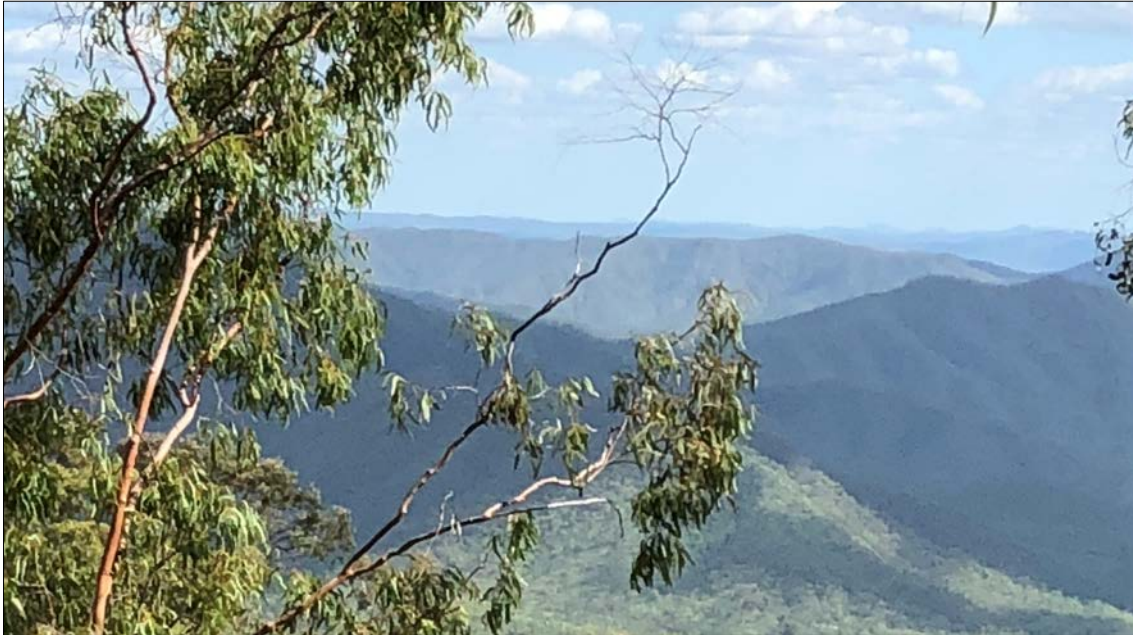
Figure 3: Image of the local terrain with a view towards the south-east

One of the first responders to the report of the accident was from QPWS. He reported that the Mount Windsor National Park area is susceptible to strong and gusting wind conditions, and that those conditions were present on the day of the accident. Figure 3 depicts the local terrain about 500 ft below the elevation of the accident site with a view towards the south-east, the direction of the forecast wind.

View towards the south-east, the direction of the forecast wind, at about 3,000 ft elevation. The helicopter wreckage was located further inland behind the photographer at an elevation of about 3,500 ft, with surrounding peaks of about 4,500 ft.
 Source: ATSB

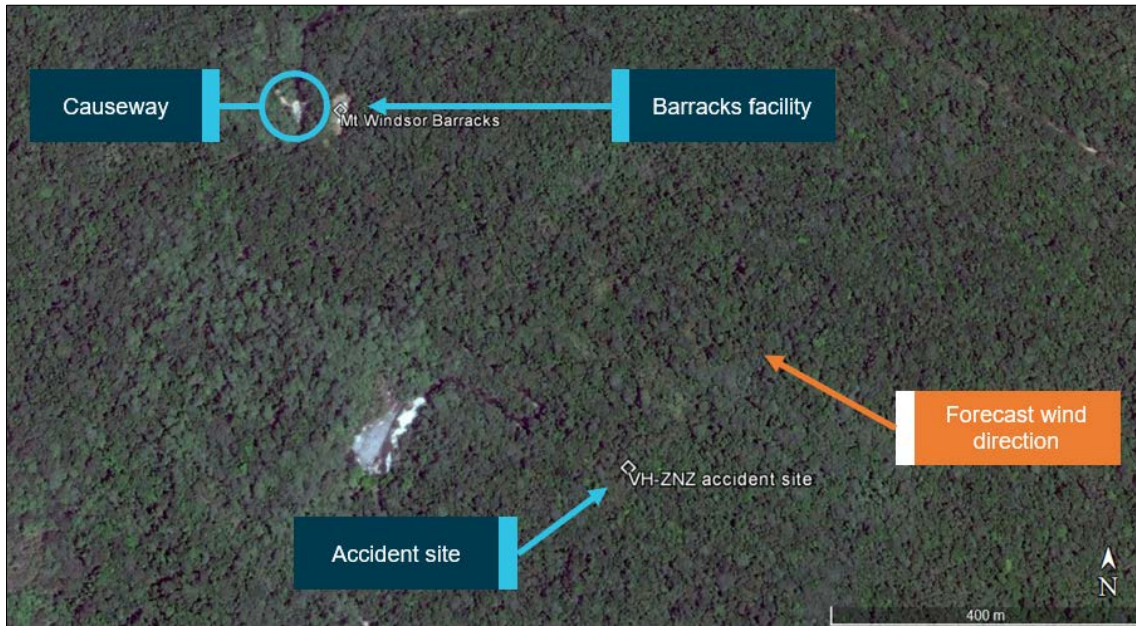
Figure 4: Accident site relative to barracks facility and causeway

At about 1244, the Australian Maritime Safety Authority's Joint Rescue Coordination Centre (JRCC) detected a signal from the helicopter's emergency locator transmitter. At about 1432, the helicopter wreckage was located in the dense rainforest of Mount Windsor National Park, about 500–600 m south-east of the barracks facility (refer to Figure 4 in the section titled *Wreckage and impact information*).

Forecast wind direction indicating the accident site was located about 500–600 m upwind of the barracks facility and causeway.
 Source: Google earth, annotated by ATSB
